**DEPARTMENT OF TRANSPORTATION**

**Denial of Motor Vehicle Defect Petition**

**SUMMARY:** This notice sets forth the reasons for denying a petition (DP14-003) submitted to NHTSA 49 U.S.C. § 30162, 49 CFR Part 552, requesting that the agency open “an investigation into low-speed surging in the 2006-2010 Toyota Corolla [vehicles] with ETCS-i, in which the brakes fail to stop the vehicle in time to prevent a crash.”

## **Appendix - Petition Analysis - DP14-003**

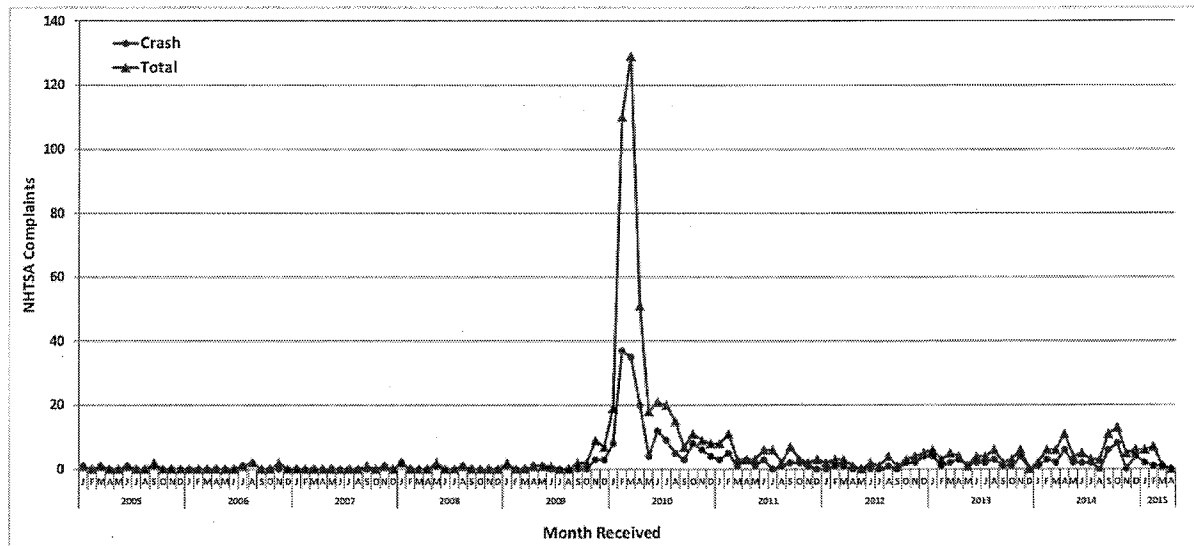
Figure 2. MY 2005-2015 Toyota Corolla Speed Control Complaints by Month Reported.

Complaints to ODI alleging SA related crashes are far less common. In the same period from 2004 through 2008 that the pedal error study identified over 2,400 pedal error related crashes in North Carolina police reports, ODI received less than 40 complaints alleging SA crashes in North Carolina in all light vehicles – or less than 2 percent of the number of crash incidents identified in the pedal error study. However, publicity can significantly increase ODI complaint volumes, as is evident for Toyota Corolla vehicles equipped with ETCS-i, which saw a 7,900% increase in speed control complaints alleging crashes and a 12,800% increase in total speed control complaints from the first quarter of 2009 to the first quarter of 2010, after news media coverage of Toyota's pedal entrapment and sticky pedal recalls (Figure 2). Each of these
